STRENGTHENING OF KEYED LONGITUDINAL
CONSTRUCTION JOINTS IN RIGID PAVEMENTS

R. W. Grau

Army Engineer Waterways Experiment Station

TECHNICAL REPORT NO. AFWL-TR-72-174

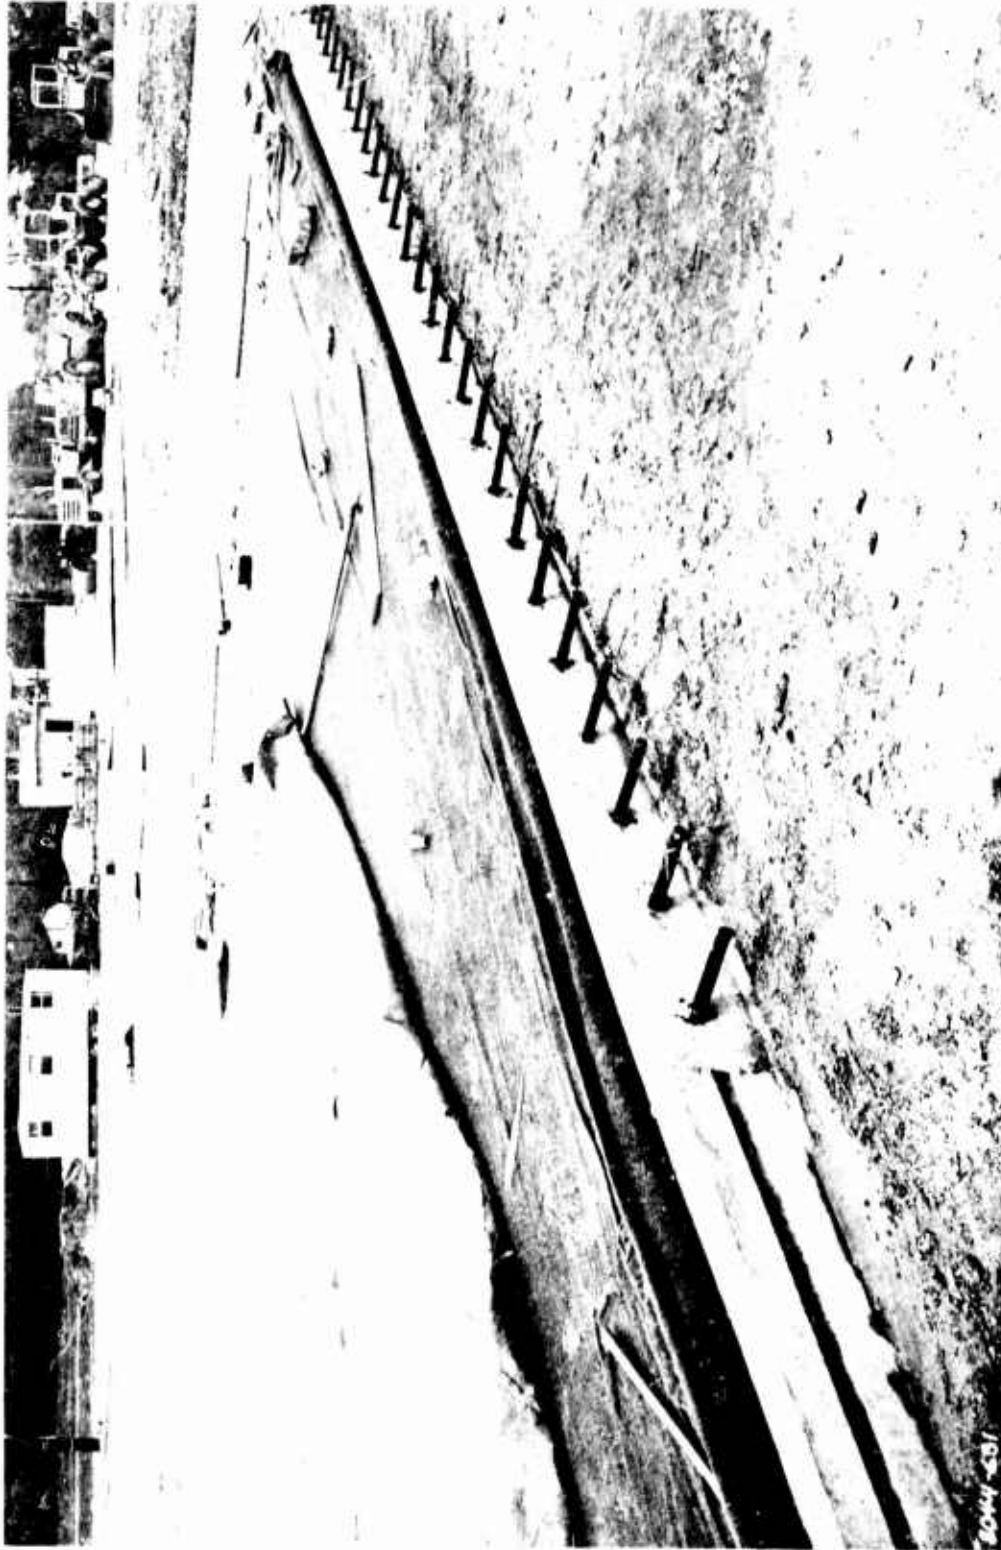
Figure 14. View of keyed and doveled longitudinal construction joint in item 1.

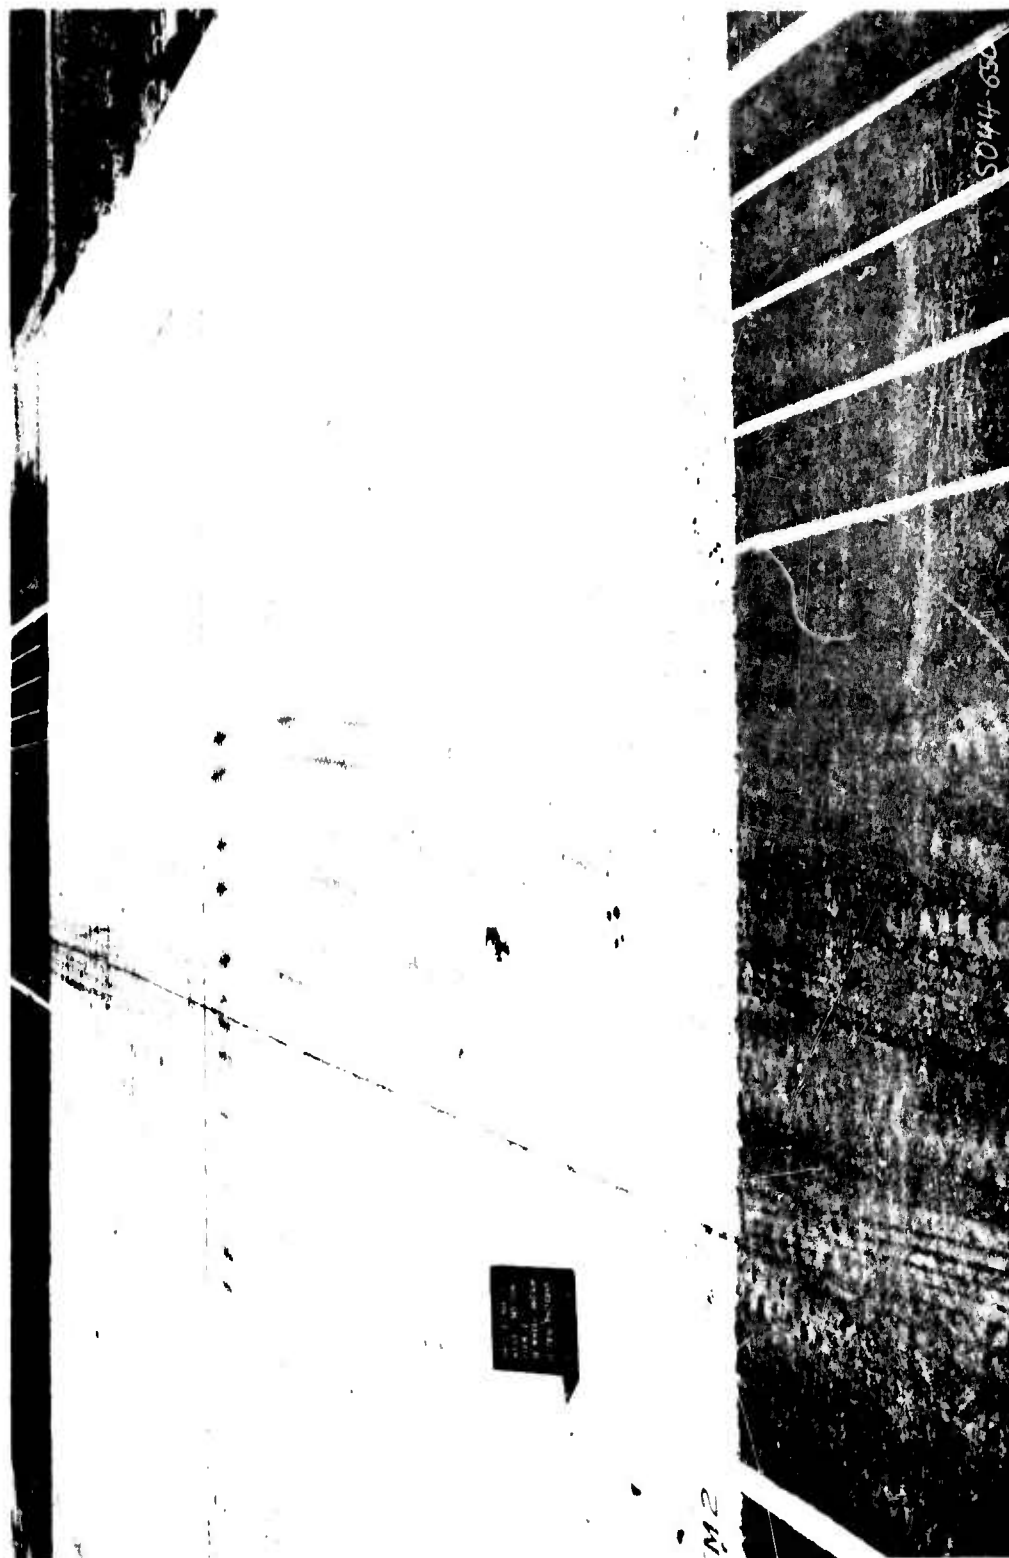
There were no structural cracks in the slabs in item 2 before traffic was commenced (figure 35). The only defect noticed prior to traffic

Figure 35. General view of item 2, 360-kip, 12-wheel-assembly lane prior to traffic.

on the surface of the pavement was a spall along the transverse joint between the northeast and northwest slabs. Pumping at the transverse joint between the east edge of the item and the transition section was noted after 8 coverages. After 16 coverages, passage of the test cart caused a small amount of clear water to squirt out around the edges of two of the 8-in.-diam holes located at the longitudinal construction joint in the western half of the item. This indicated that there was a very poor, if any, bond between the slab and the sand-cement grout used to fill the underreamed void and 8-in.-diam access holes. The lack of bond did not appear to have any effect on the strengthening characteristics. Slight spalling and flaking were also observed around the edges of the access holes after 16 coverages of traffic.

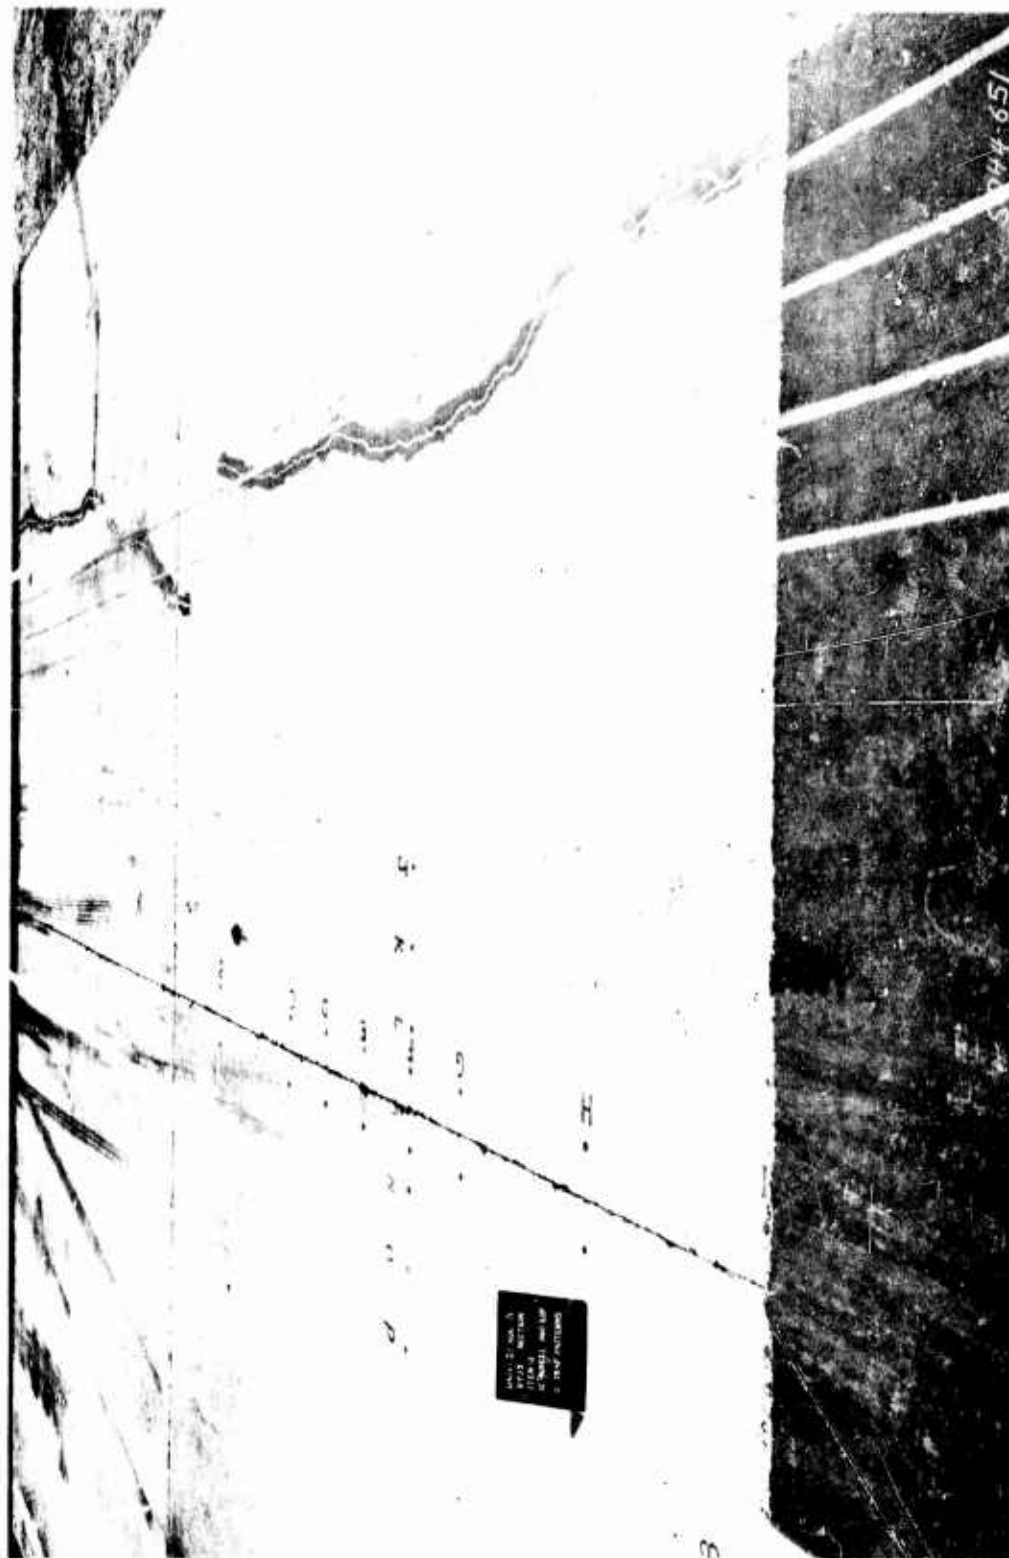
A general view of item 3 prior to test traffic is shown in figure 45. As can be seen in this photograph, several cracks developed during the curing of the slab. An epoxy cement was placed under pressure (10 psi) into the longitudinal cracks located in the southeast slab running from the south free edge of the slab to the longitudinal joint. Epoxy cement was first applied to the surface of the pavement and allowed to cure before the epoxy cement was forced under 10-psi pressure into the cracks. There was also a transverse crack between the southwest and southeast slabs parallel to the weakened-plane construction joint. However, since this crack developed prior to the construction of the weakened-plane joint, it was decided to consider the crack as the joint between the two slabs.

Figure 45. Item 3, 360-kip, 12-wheel-assembly lane prior to traffic.

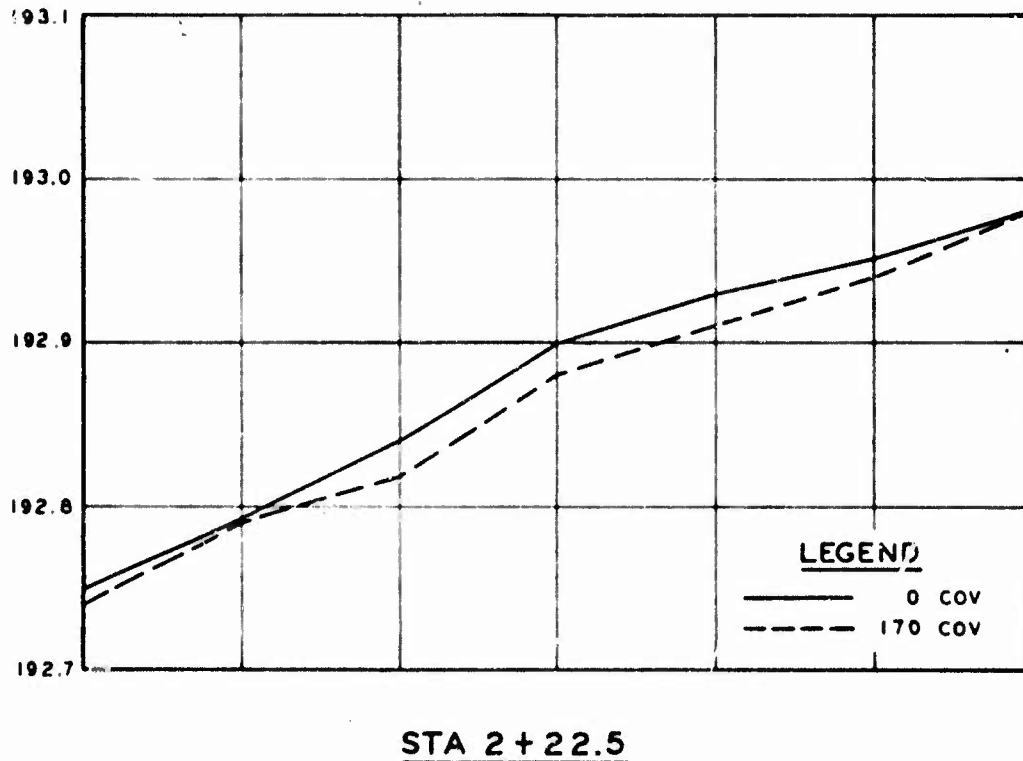
Typical cross-section plot showing the permanent deformation that occurred during traffic is shown in figure 68. The maximum deformation measured at the conclusion of traffic was 0.24 in. As shown in figure 69, a maximum total deflection of about 0.13 in. was measured prior to traffic.

Figure 68. Typical cross sections of item 2, 166-kip, twin-tandem-assembly lane.

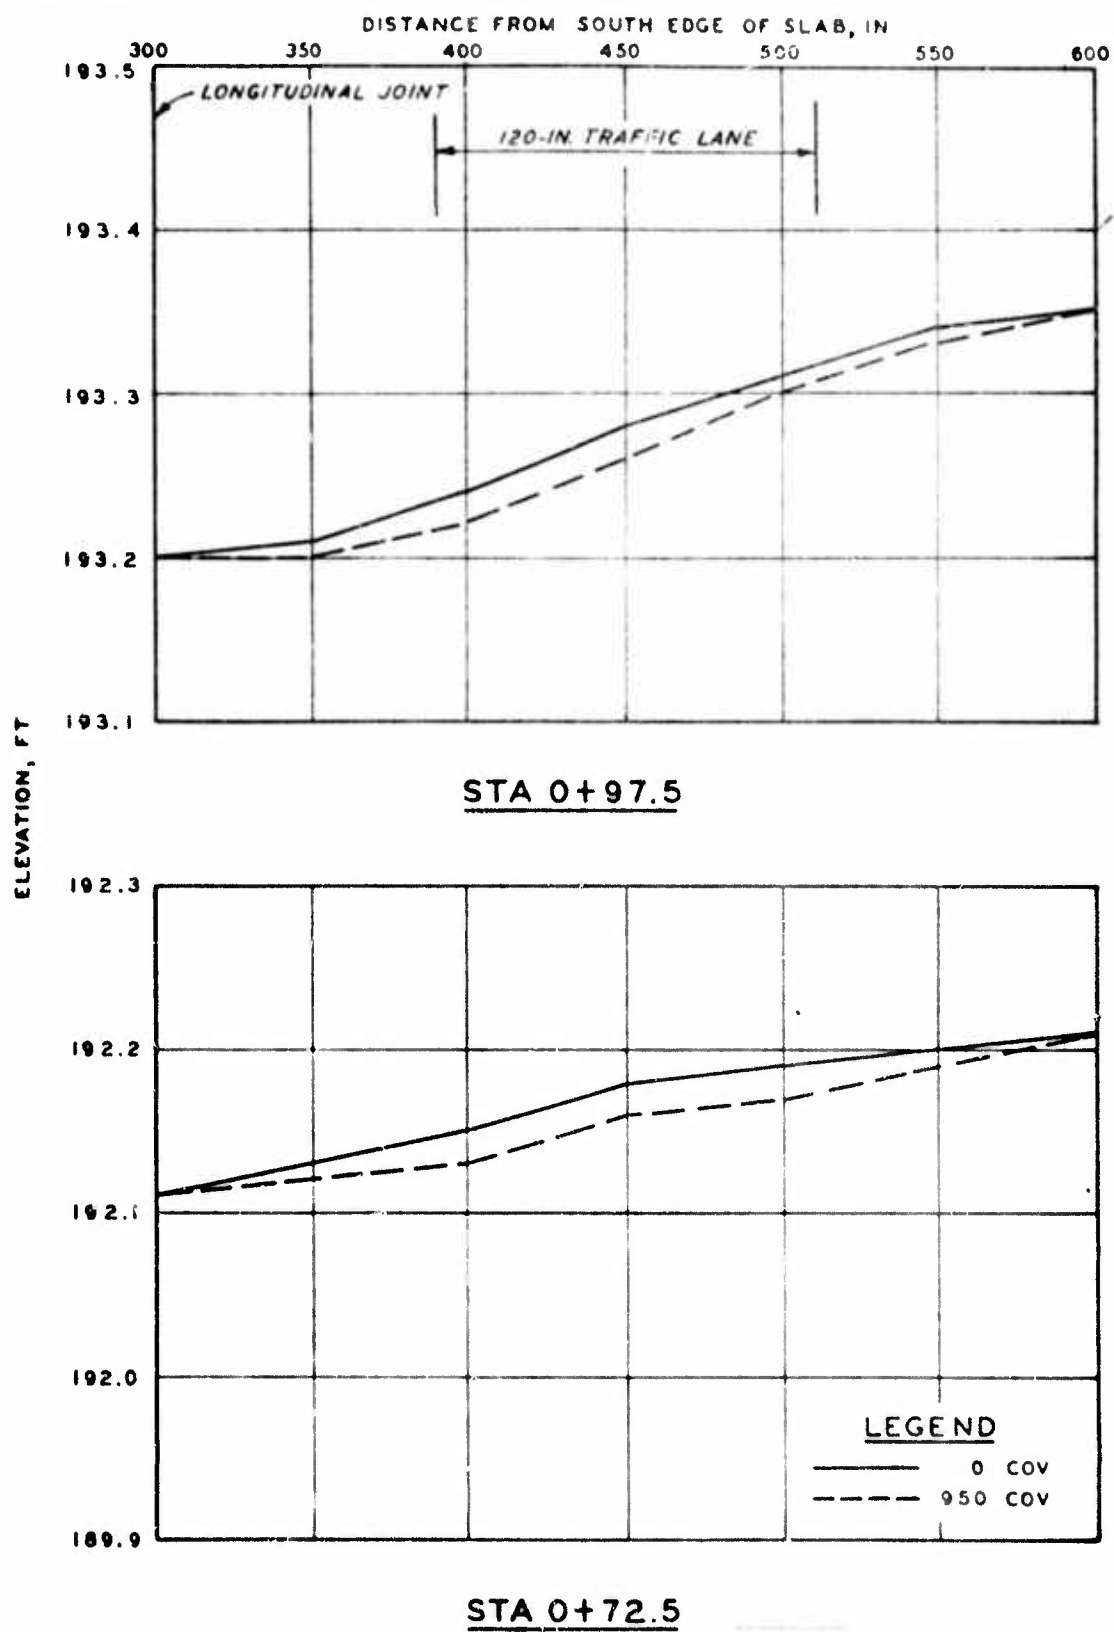
The maximum total deflection measured prior to traffic was about 0.09 in. A plot of the deflection basin measured before applying test traffic is shown in figure 74. As can be seen from the typical cross-section plots shown in figure 75, the average permanent deformation after failure was about 0.18 in., and the maximum permanent deformation was 0.24 in.

Figure 75. Typical cross sections of item 4, 166-kip, twin-tandem-assembly lane.
